J. ARONSTEIN

HAZARDOUS FPE CIRCUIT BREAKERS AND PANELS

Information for Inspectors and Homeowners

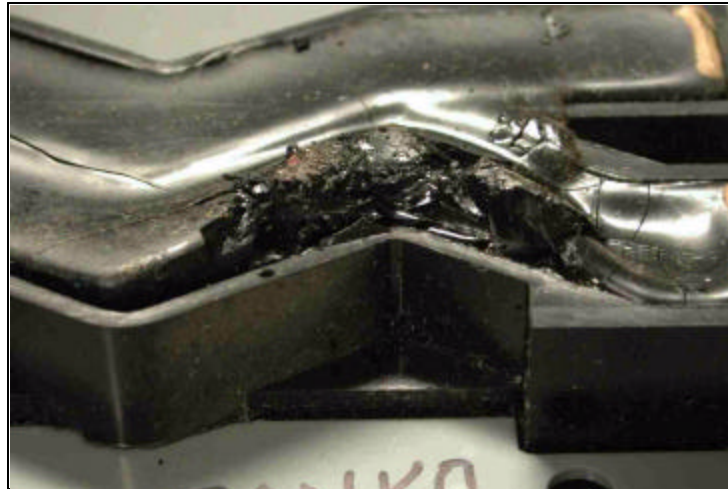
Of the three types illustrated, the one shown in Figure 2-C is known to have a high probability of deteriorating and overheating of the stab socket structures when subjected to significant current flow. Each individual stab socket plate is connected to its bussbar via a post (spacer), and the assembly is held together by an 8-32 steel screw. FPE panels with this construction are prone to overheating failure. The seven panels of the present study that showed evidence of serious overheating were constructed this way. One example is shown in Figure 3.

FIGURE 3 - OVERHEATING AT THE CONTACT BETWEEN THE BUSSBAR AND THE STAB SOCKET ASSEMBLY CAUSED THIS DAMAGE TO THE INSULATION.

(This view is of the backside of the panel. The damage cannot not be seen unless the panel is taken out of the enclosure.)

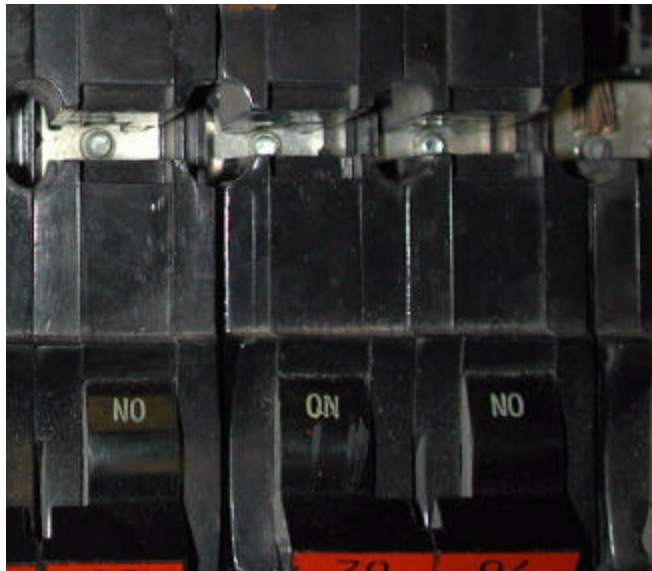
FIGURE 5 - THE ENDS OF THE SCREWS HOLDING THE STAB SOCKET PLATES ARE VISIBLE BETWEEN THE TWO ROWS OF BREAKERS. THIS IDENTIFIES IT AS A PANEL OF THE TYPE SHOWN IN FIGURE 2-C

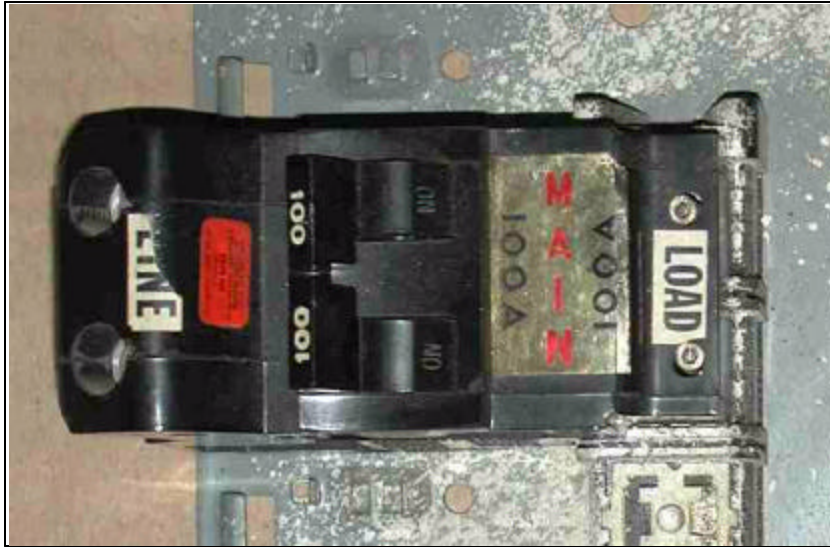
Some FPE Stab-Lok® panels have 100-amp main breakers that feed into the bussbars through the same plate and post system. In this design, the two main breaker output terminals do not have the stab type contact. Instead, each one is screwed down to a plate the same size as the stab socket plate, but which has a threaded hole in it instead of the stab openings. As with the plate and post assembly, the screws clamping the main breaker terminals are size 8-32, which is absurdly small for clamping the terminals of a 100-amp main breaker.

FIGURE 6 - FPE 100-AMP MAIN BREAKER CONNECTS TO THE BUSBARS THROUGH THE PLATE & POST CONFIGURATION, USING ONE SOCKET-HEAD 8-32 SCREW AT EACH TERMINAL TO ATTACH TO THE CONTACT PLATE.

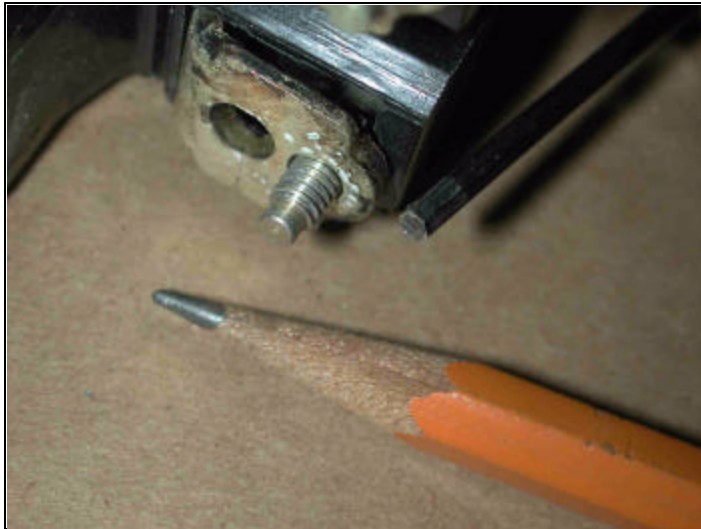
To put the diameter of the 8-32 screw in perspective, it is the same size as used on common receptacles for connecting #14 or #12 copper wire (for 15- and 20-amp circuits), and has a diameter of only about 5/32". An FPE panel and main breaker of this type is shown in Figure 6. The main breaker's output terminal mounting screws and the tiny Allen-wrench that fits them are shown in Figure 7.

FIGURE 7 - ONE LOAD-SIDE CONTACT AND ITS 8-32 CLAMPING SCREW, ON THE FPE 100-AMP MAIN BREAKER OF FIG. 6. THE SCREW-HEAD TAKES A 3/32" ALLEN WRENCH, WHICH IS ONLY SLIGHTLY LARGER THAN THE LEAD OF THE #2 PENCIL.

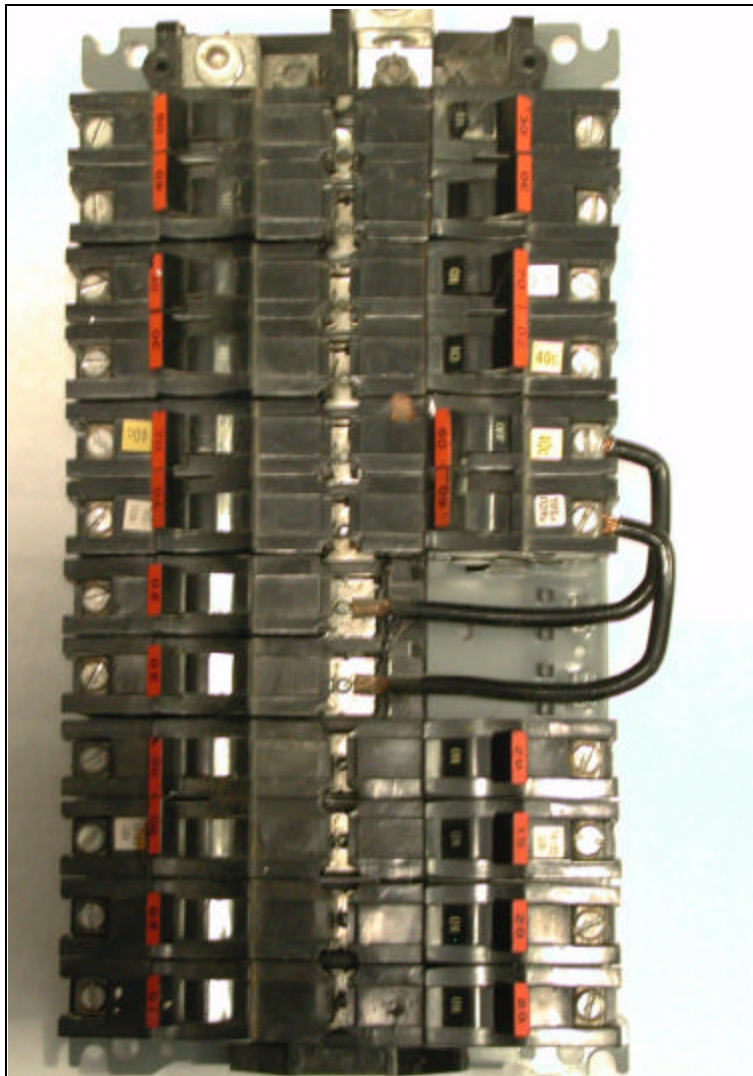
FIGURE 8 - FPE STAB-LOK® "RULE-OF-SIX" (SPLIT-BUS) PANEL WITH NO MAIN BREAKER. THE JUMPER CABLES ON THE RIGHT SIDE FEED THE LOWER SECTION.

On first glance, the FPE Stab-Lok® panel previously shown in Figure 8 looks normal. In fact, however, it clearly demonstrates several of the hazardous failure modes discussed in the previous sections. It is one of 28 collected for the recent testing. It is from a home built in 1974, whose new owners had determined in 1999 that it should be replaced. Their decision to replace it was in part prompted by information available on the internet regarding FPE breaker problems.⁷ According to the homeowner, who sent it to me for examination and testing, *"We recently had it replaced and found the breaker to the dryer fried in just the way described. Our electrician was astonished. Two others we had bids from dismissed our concerns with contempt."*⁸

There are additional problems in this panel. Overheating damage occurred to the insulation on the backside of the panel. Further, in addition to the dryer breaker that failed (jammed) in the home, two other two-pole breakers from this same panel failed in the lab testing. All this in a panel that looked OK from the front!

Everything in the home was functioning. The dryer worked. Why wouldn't it, since the circuit breaker was jammed with its contacts closed? Keep in mind that this panel is one of the "rule-of-six" configuration. Before they replaced this panel, the homeowners unknowingly had a situation where, essentially, the clothes dryer was wired straight through to the power line transformer on the pole, with no functional circuit protection at all.

There is no question but that the FPE Stab-Lok® panels should be replaced. There is no practical and safe alternative.

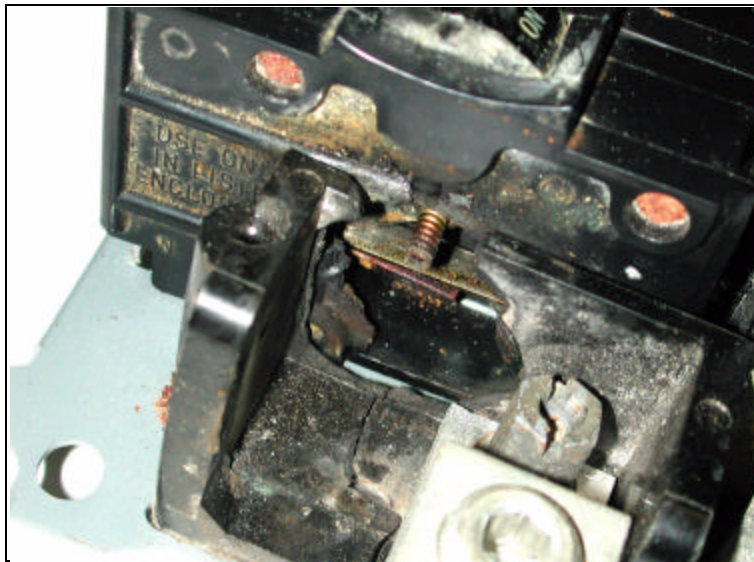
Viewing the panel from the front, some subtle signs of overheating (as previously discussed) are evident. These are subtle compared to the view looking down at the top right (dryer) breaker, as in Figure 9. The main service cable connector has been rotated out of the way for better visibility of the damage. The plastic insulator is burnt and cracked. The breaker's internal mechanism can be seen through the hole burned through its side. Figures 10 and 11 show the damage to the separate items.

FIGURE 9 - VIEW DOWN TOWARD UPPER RIGHT OF PANEL SHOWN IN FIG. 8. THE FPE STAB-LOK® TWO-POLE 30-AMP BREAKER FED THE CLOTHES DRYER.

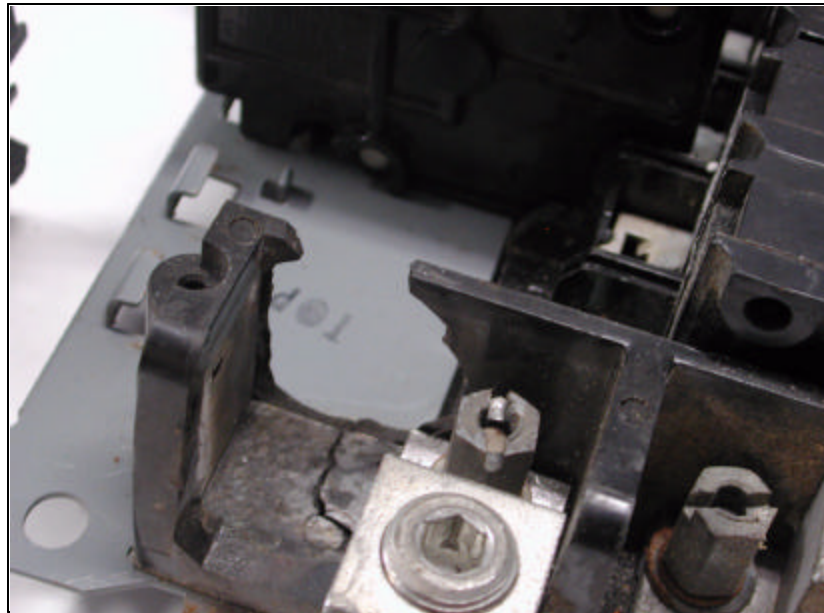
FIGURE 10 - THE DAMAGE TO THE INSULATING STRUCTURE OF THE PANEL (FIG. 8) IS MORE CLEARLY VISIBLE WITH THE BREAKER REMOVED.

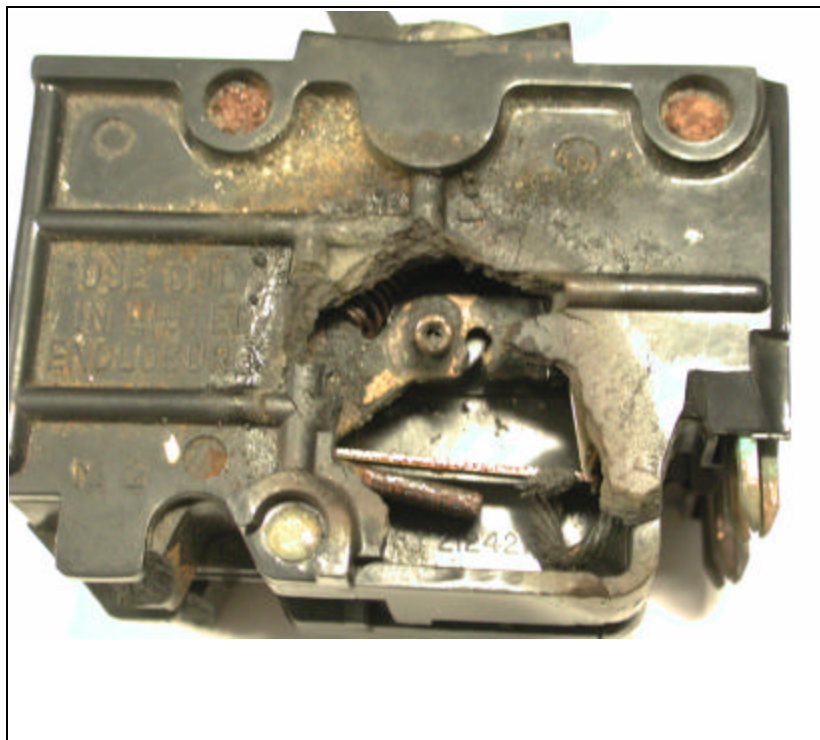
FIGURE 11 - THE FAILED FPE STAB-LOK® DRYER BREAKER (UPPER RIGHT, FIG. 8)

The damage to the breaker, from some previous short circuit or failure event, is exactly as had been demonstrated in the tests done for CPSC.^{2,3,4} Those tests demonstrated that, when an FPE breaker jammed and the current exceeded about 300% of the breaker's rating, the side of the breaker disintegrated and/or ignited from the heat being generated within the breaker. This is due to resistive heating of the breaker's internal current-carrying components, mainly the bimetal element and the flexible copper braid that connects to it. This is not an arcing failure, although the damage to the insulating materials of the breaker and panel sets the stage for an arcing fault to occur.
