J. ARONSTEIN

HAZARDOUS FPE CIRCUIT BREAKERS AND PANELS

Information for Inspectors and Homeowners

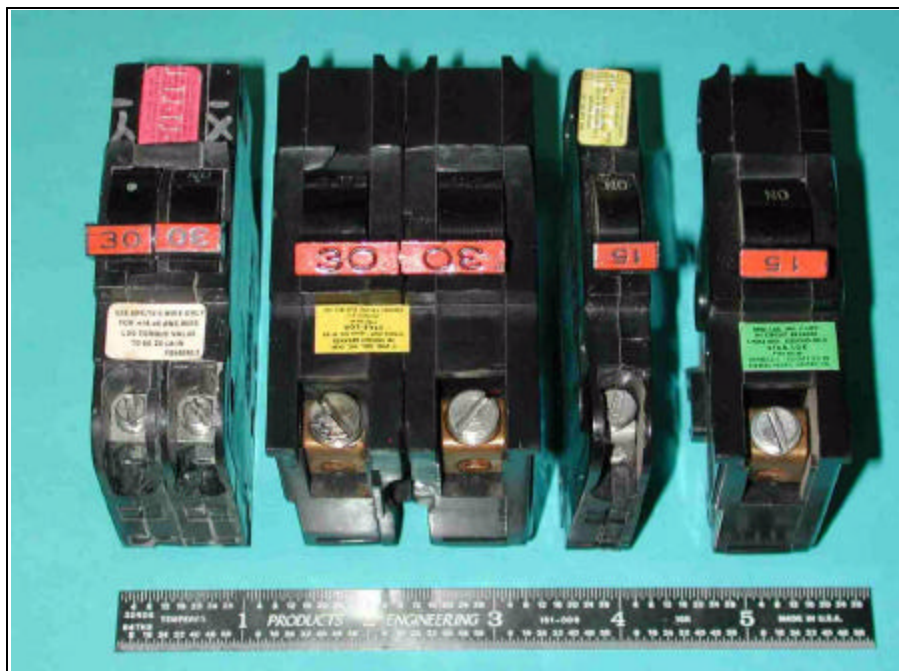
FIGURE 1 - REPRESENTATIVE SAMPLES OF HALF- AND FULL-WIDTH FPE STAB-LOK® CIRCUIT BREAKERS (left to right: 1/2-width double pole, full-width double pole, 1/2-width single-pole, full width single-pole)
Note that the color and style of the handle varied over the years.

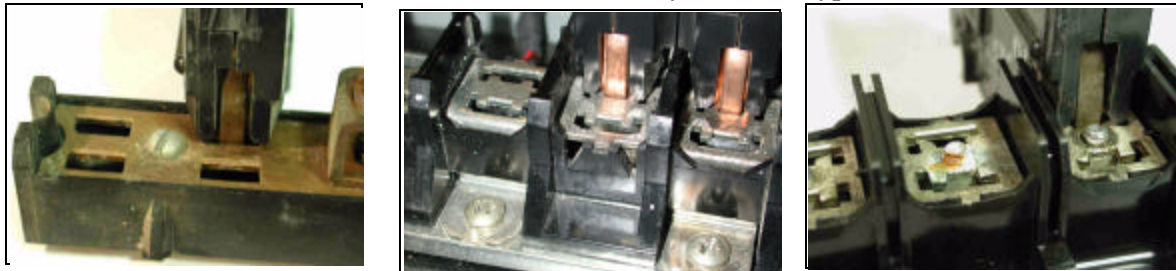
- A. Copper buss bar with punched openings.**
- B. "Z" clip, clamped to bussbar with 10-32 screw.**
- C. Stab socket on a post, attached with an 8-32 steel screw.**

FIGURE 2 - THREE DIFFERENT FPE STAB-LOK® SOCKET DESIGNS

Of the three types illustrated, the one shown in Figure 2-C is known to have a high probability of deteriorating and overheating of the stab socket structures when subjected to significant current flow. Each individual stab socket plate is connected to its bussbar via a post (spacer), and the assembly is held together by an 8-32 steel screw. FPE panels with this construction are prone to overheating failure. The seven panels of the present study that showed evidence of serious overheating were constructed this way. One example is shown in Figure 3.

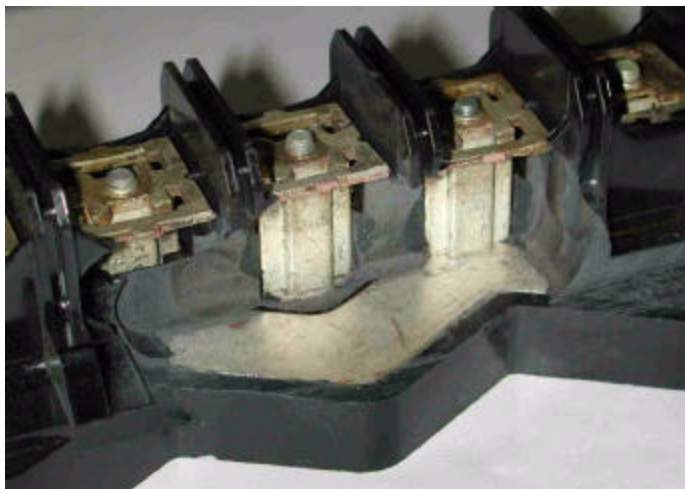
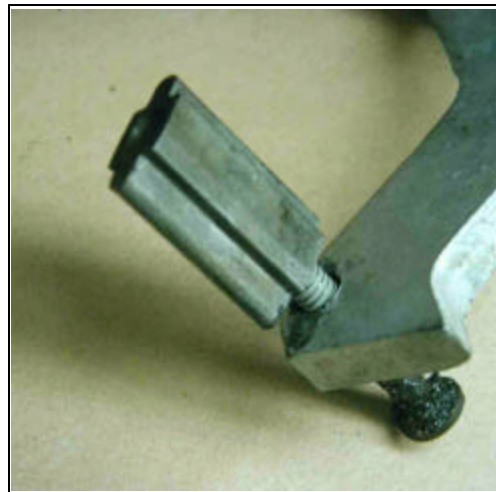
FIGURE 4 - CONDUCTING PATH FROM BUSSBAR TO STAB SOCKET

A more serious failure of this type has been documented.¹ In that instance, the failure had been severe enough to ignite a smoldering fire on the plastic insulating material. The fundamental weakness in this design is the use of a single, relatively flimsy 8-32 screw to hold a structure together that can feed up to four half-width breakers with a total "ampacity" (rated circuit capacity) up to about 160 Amps. Figure 4 shows how the stab socket plate and post are attached to the bussbar.

A. Cutaway - Bussbar, Post, and Stab Socket Plate.

B. Bussbar, Screw, and Post
